**FOWIND (Facilitating Offshore Wind in India)** is a European Union funded project, led by Global Wind Energy Council (GWEC), which promotes offshore wind power to facilitate India's transition towards a low carbon energy future.

### The WindCube v2 Offshore : the Best-in-Class Solution for Offshore Wind Resource Assessment.

### The 5<sup>th</sup> of May 2016: Demonstration at NIWE Office in Chennai

## 22nd of January 2018 : Windcube Maintenance Activity

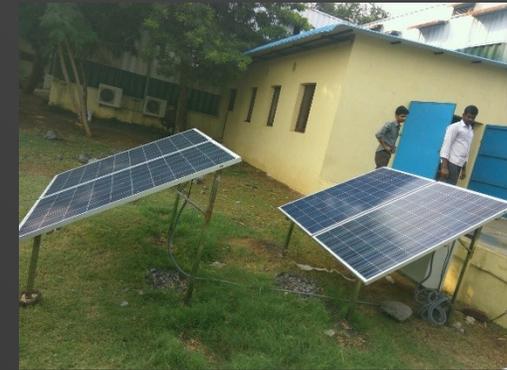
**Configuration :** To provide power to the Windcube Lidar offshore, meaning off-grid as well, we need a self power production usable as an UPS (Uninterrupted Power System). The solution has been designed based on solar energy, with batteries to have power all day long. We have 4 solar panels (4 x 250 W = 1000 W) and 4 batteries (4 x 200 Ah = 800 Ah). The batteries and solar panels are connected together through a control panel, managing the charge and discharge of the batteries. The control panel displays, sends and saves the voltage from the batteries. Whenever the batteries voltage is too low, meaning a low charge level of the batteries, an alert is sent by email.

Solar panels : 1000 W

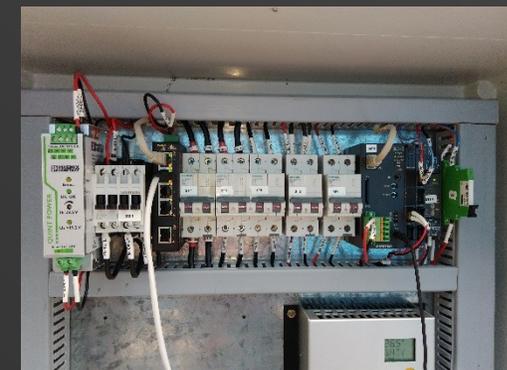
Control panel connected to battery and solar panels

**Control Panel :** To ensure connections between batteries, solar panels and Lidar, we designed a control panel. It has been assembled by ELDAC in Chennai. As explained earlier, the control panel manages the charge and discharge of the batteries with the essential Solar Charge Controller. The control panel includes also circuit breakers, converters and a router to connect the LAN cables. It displays, sends and saves the voltage from the batteries. Power is also provided to the satellite antenna.

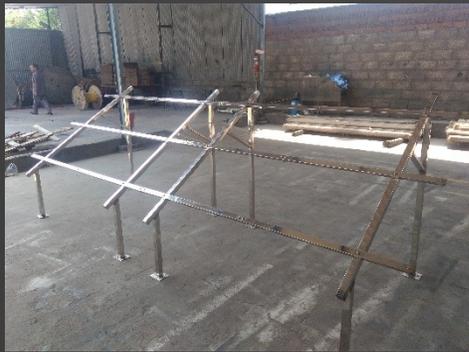
**Solar panel stands:** To fix properly and strongly the solar panels to the platform, we designed and made dedicated solar panels stands. They have been made by Spearhead in Chennai. They are made of Stainless Steel 316. Their strong structure is able to withstand high wind. The material used is able to withstand the salty conditions.

Solar panel stands : SS316

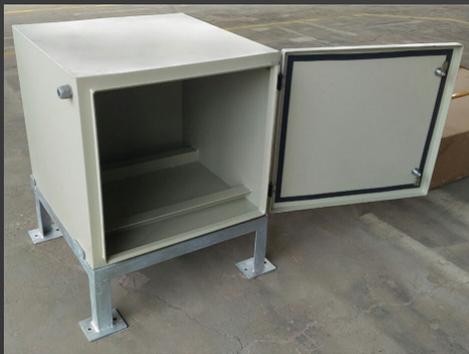
**Battery box :** The batteries need to be protected from outside conditions, including rain, wind and salty conditions. We designed and made a dedicated battery box. It has been made of galvanized aluminum by Spearhead in Chennai. They are hermetic with holes for the battery cables. Water from possible condensation should be avoid with moisture absorber.

Battery box : galvanized aluminum

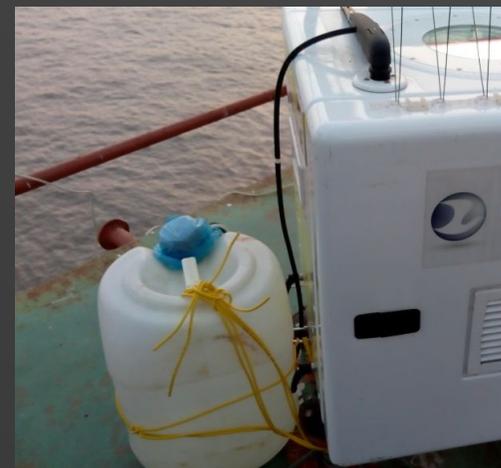
MeteoPole noticed that the Water Pump is not completely at the bottom of the Water Tank so, this Water Tank should be fill in more often than expected.

Water Tank

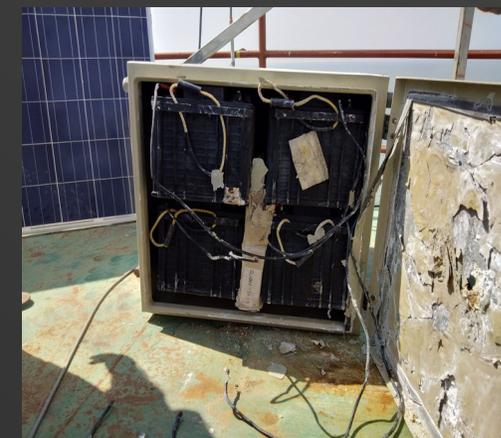
Once on the platform, the FOWIND team noticed that the battery box has fallen on the ground. After further inspection, the four batteries are still working and are well connected to the Windcube. Some small scratches can be seen on the solar panels which do not affect their efficiency. A final verification shows that the output of the power pack fits the requirements of the Windcube.

Fallen Battery Box

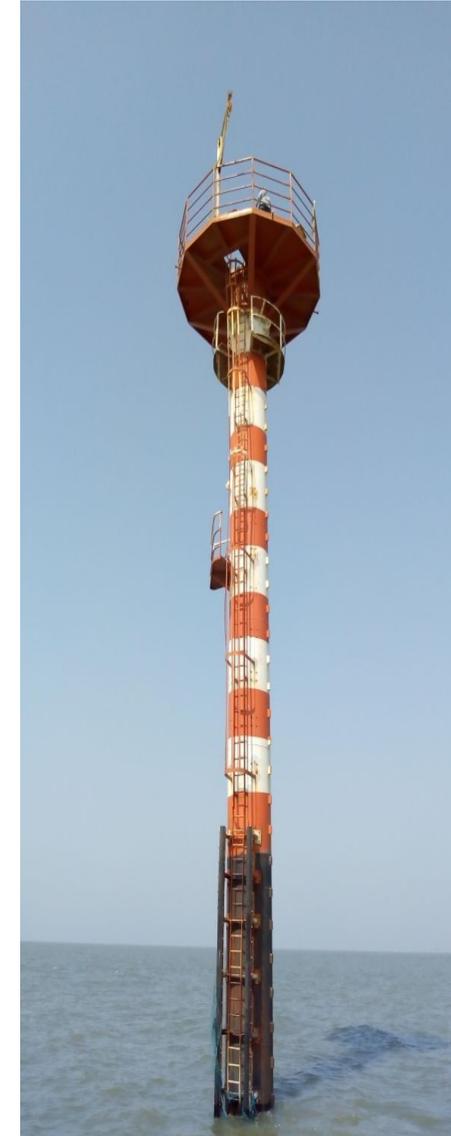
The Network Connectivity is quite bad on the platform so, we lose the connection with the Windcube during some parts of the day, especially during working hours.

GSM Network Connectivity Strength

This network connectivity issue may be solved by using a High Frequency Transmitter or increasing Airtel connectivity with the help of Airtel. It is not mandatory and this issue will be addressed by NIWE in the next months.

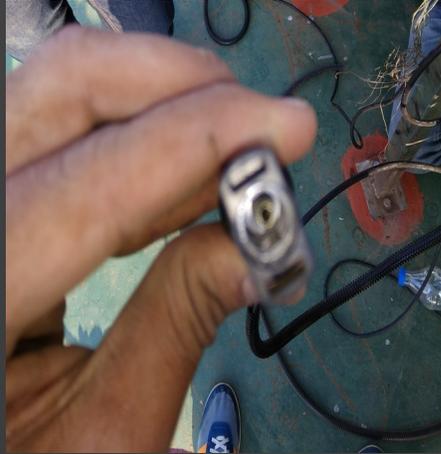
Corrosion Inside the Connector

On the platform, we have noticed that the connections of 2 solar panel were not good due to corrosion inside of the connector and were therefore not properly connected to each other. The connectors were fixed with insulation tape in order to avoid the same thing in future.

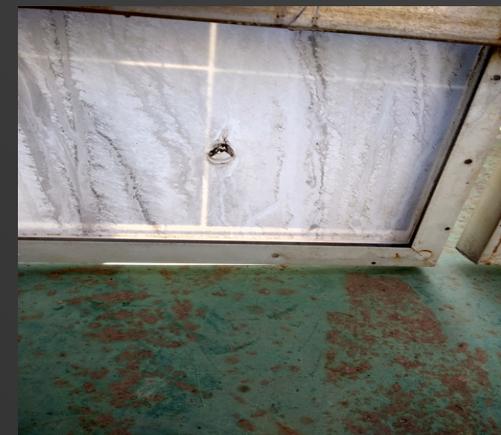
Small Scratch on Solar Panel

We also observed some scratches on the back side of a solar panel, but it should not affect its efficiency as it remains superficial.

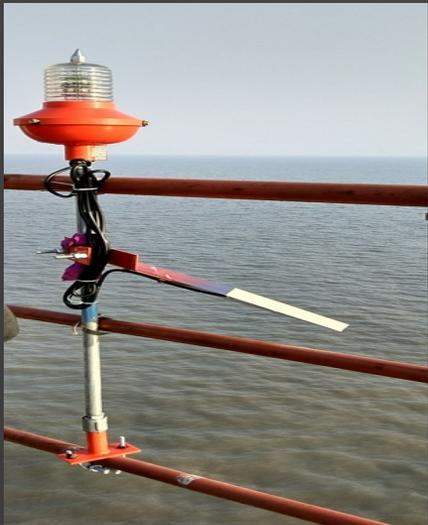
WISE has Installed an aviation lamp with separate solar based power supply and battery.

Aviation lamp

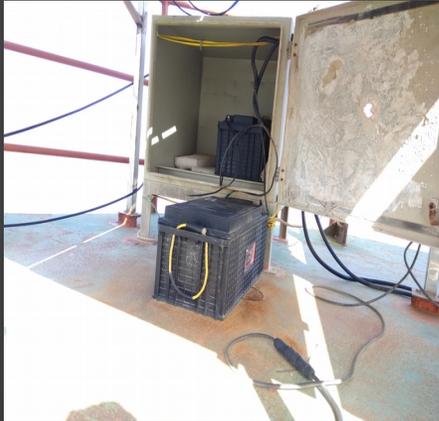
Once we reached on the platform we noticed that out the 4 batteries we found 2 batteries were on the floor, one in a battery box and one battery on the edge of falling into the sea because of the platform continuous movements. From the 3 available batteries, one is completely damaged and we can not use it any more, we managed to turn on the Windcube with 2 batteries. Fortunately, the output voltage were still matching the LiDAR requirements (25V). Finally, we fixed the battery box properly and tied it with copper cable so in the future we can cope with this problem.

The remaining battery inside the battery box

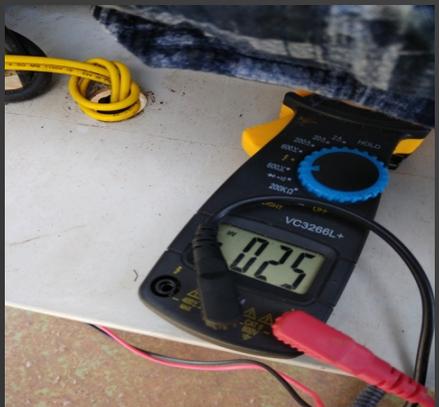
After solving the battery problem and having finished the inspection of the control panel , we have verified their output voltage and connected them to the LiDAR for power supply. The water tank was damaged so we replaced it, we topped it up with distilled water required for LiDAR and cleaned the air filter & solar panel and other small cleaning activities were also performed.

Output voltage of the 2 batteries Power pack
